## Removal of Unit 1

## Installation of Unit 2

## Cold Source Replacement

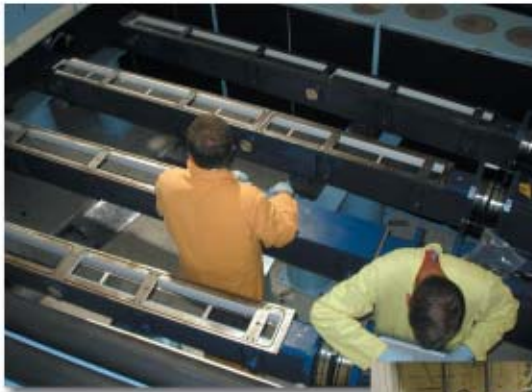
Biological shielding is removed and guides are disassembled prior to removing the Unit 1 cold source.

The bear trap is placed on special stanchions (white) to avoid misaligning the neutron guide stanchions (blue).

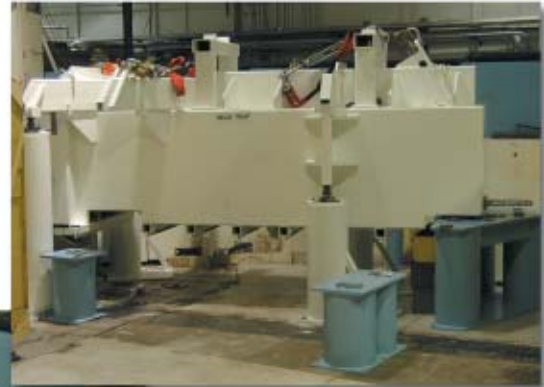
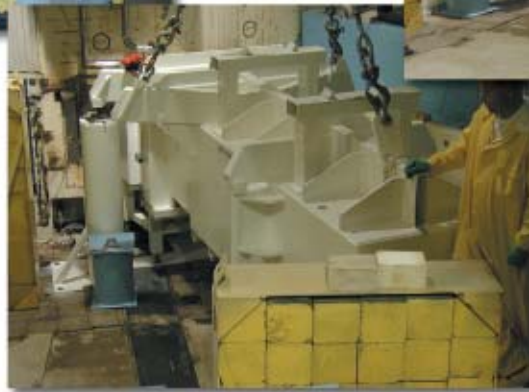
The "bear trap" transport device is moved into place to remove Unit 1.

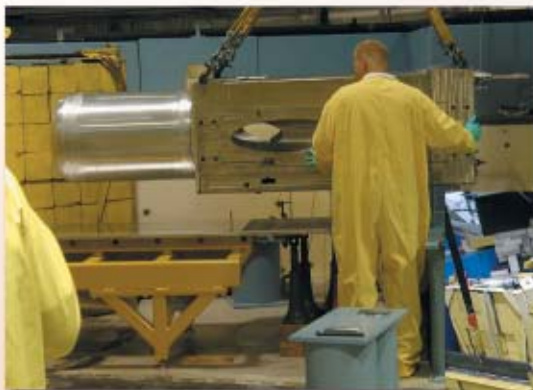
Unit 2, the new cold source assembly, is moved into place (above) and rides a track (right) into the cold source thimble.

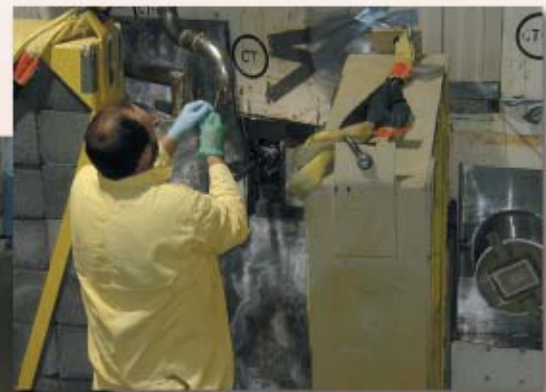
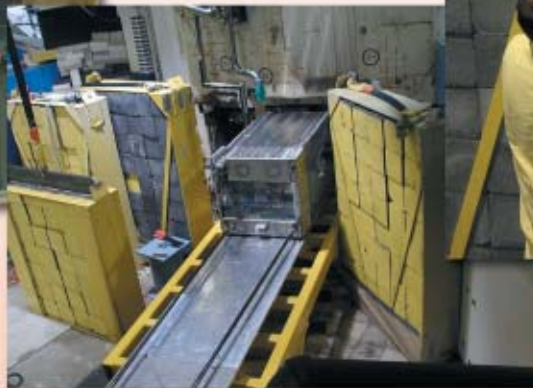
Connections to hydrogen condenser are welded into place.

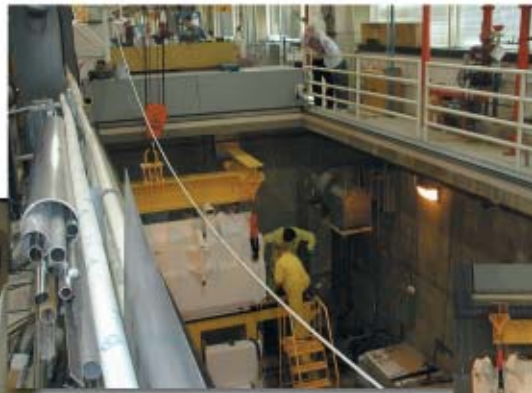
Enclosed Unit 1 is moved (left) to storage area and aligned (below) with "winter bear den" under the watchful eye of NCNR director Mike Rowe.

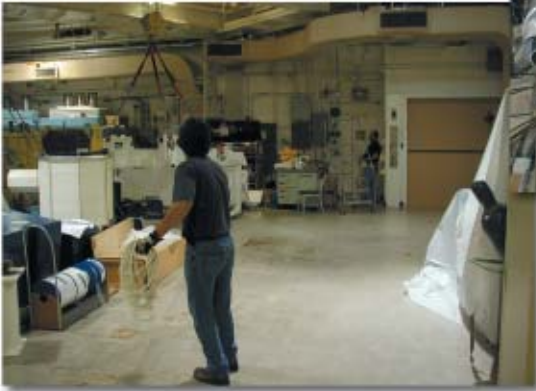
"Bear trap loaded with bear" (Unit 1) is guided toward exit for placement on a truck bed.

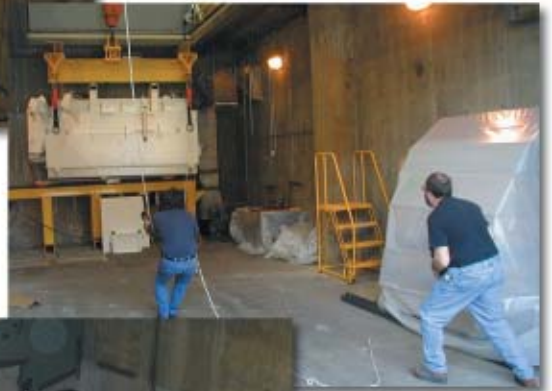
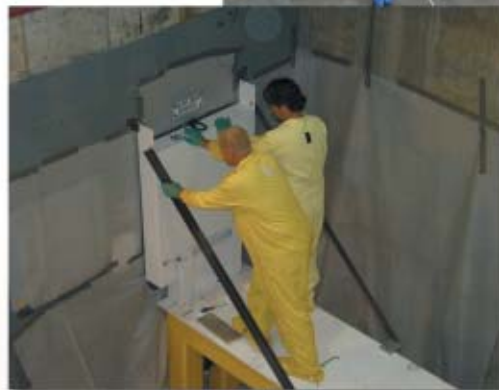
Unit 1 is sealed in storage.

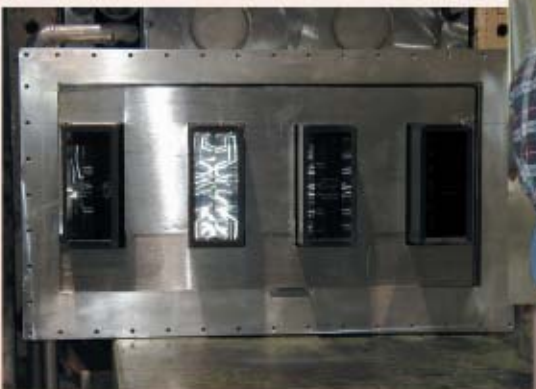
New guide tube assembly is prepared for placement.

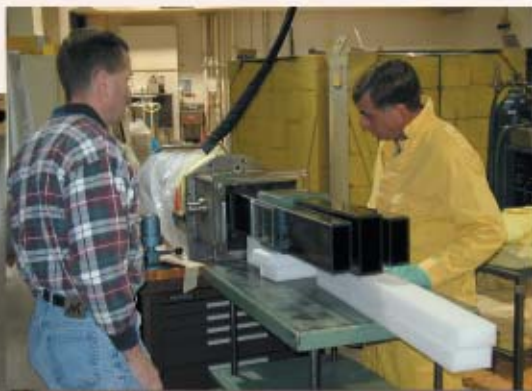
Guide tube parts are aligned.
